Water Quality Conditions in the Mad River Watershed, Vermont 1985-2015

Prepared for the
Friends of the Mad River

Fritz Gerhardt, Ph.D.

31 May 2016

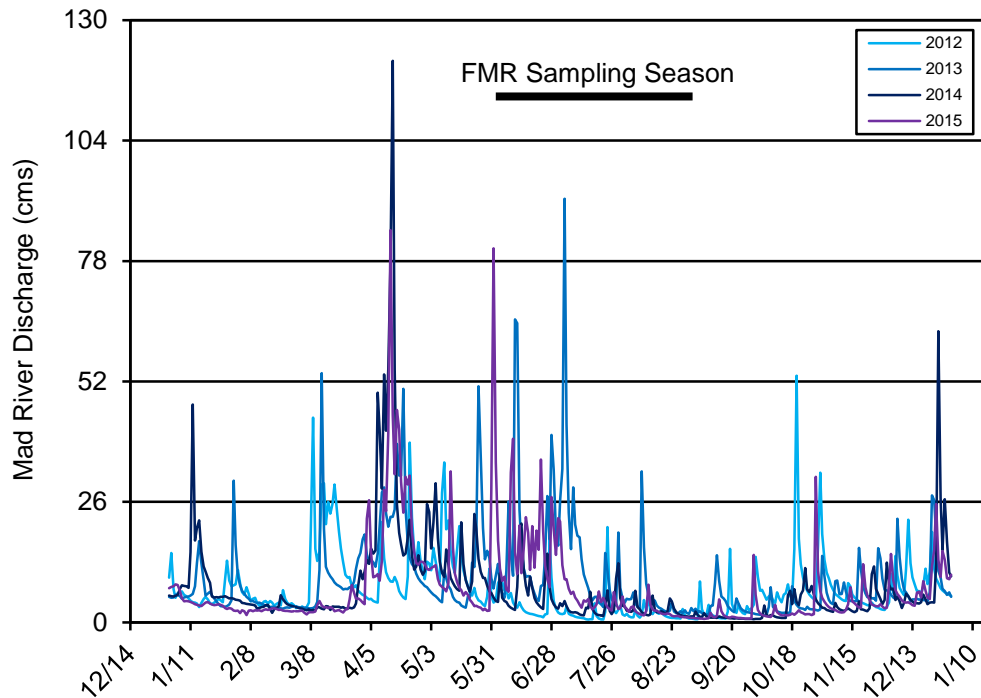
Figure 6. Stream flows along the Mad River near Moretown, Vermont during 2012-2015. Stream flows were measured by the U.S. Geological Survey (USGS station 04288000). The horizontal bar represents the general range of dates sampled by the Friends of the Mad River during 1985-2015.

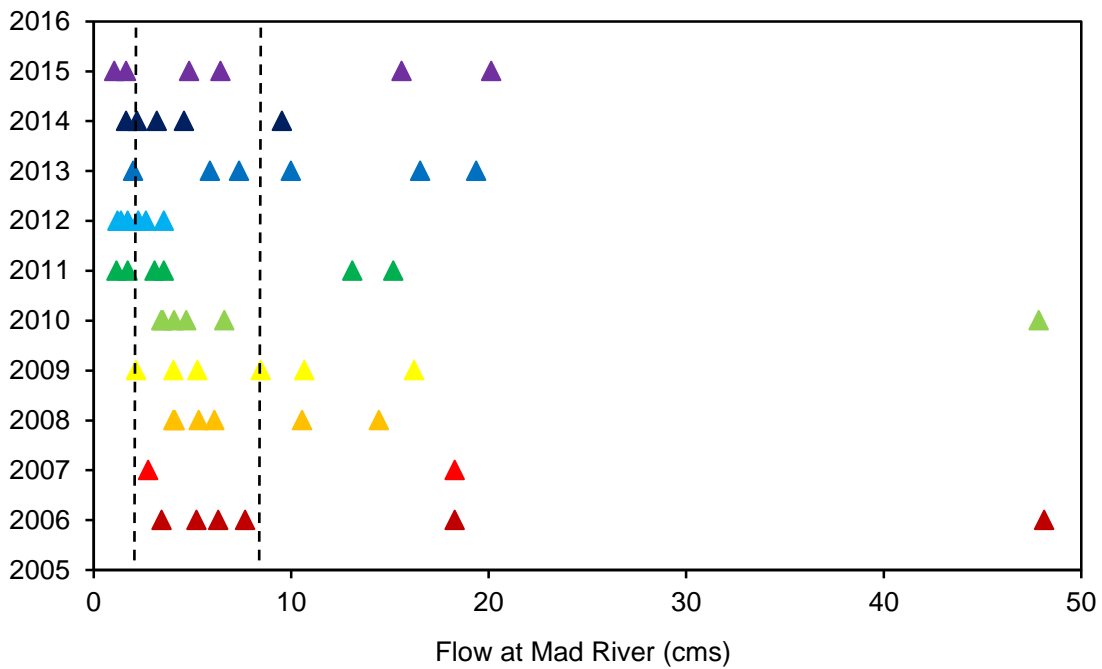
Figure 7. Stream flows measured at the USGS gage on the Mad River near Moretown, Vermont (USGS station 04288000) on each date that water quality samples were collected in the Mad River watershed during 2006-2015. The vertical, dashed lines separate low (left), moderate (center), and high (right) flows.

2012). Moderate flows were sampled on 1-5 dates, representing 33-83% of the sample dates, across the ten years. However, low flows were only sampled on 1-3 dates during 2011-2015, representing 17-50% of the sample dates (no low flows were sampled during 2006-2010). Given that the water quality standards for certain parameters (State of Vermont 2014a) are referenced to “low median monthly flows” (total phosphorus) or “dry weather base-flow conditions” (turbidity), this small number of samples collected at low flows limited our ability to use these data to evaluate whether or not individual streams or sites were meeting State water quality standards. It should also be noted that localized precipitation events may have affected flows in some but not all areas of the watershed on some dates and that the smaller streams and larger rivers may have responded differently to individual precipitation events. Given these caveats, the stream flows measured at the USGS gage on the Mad River near Moretown may not always provide an accurate representation of stream flows at individual sites on each sample date.

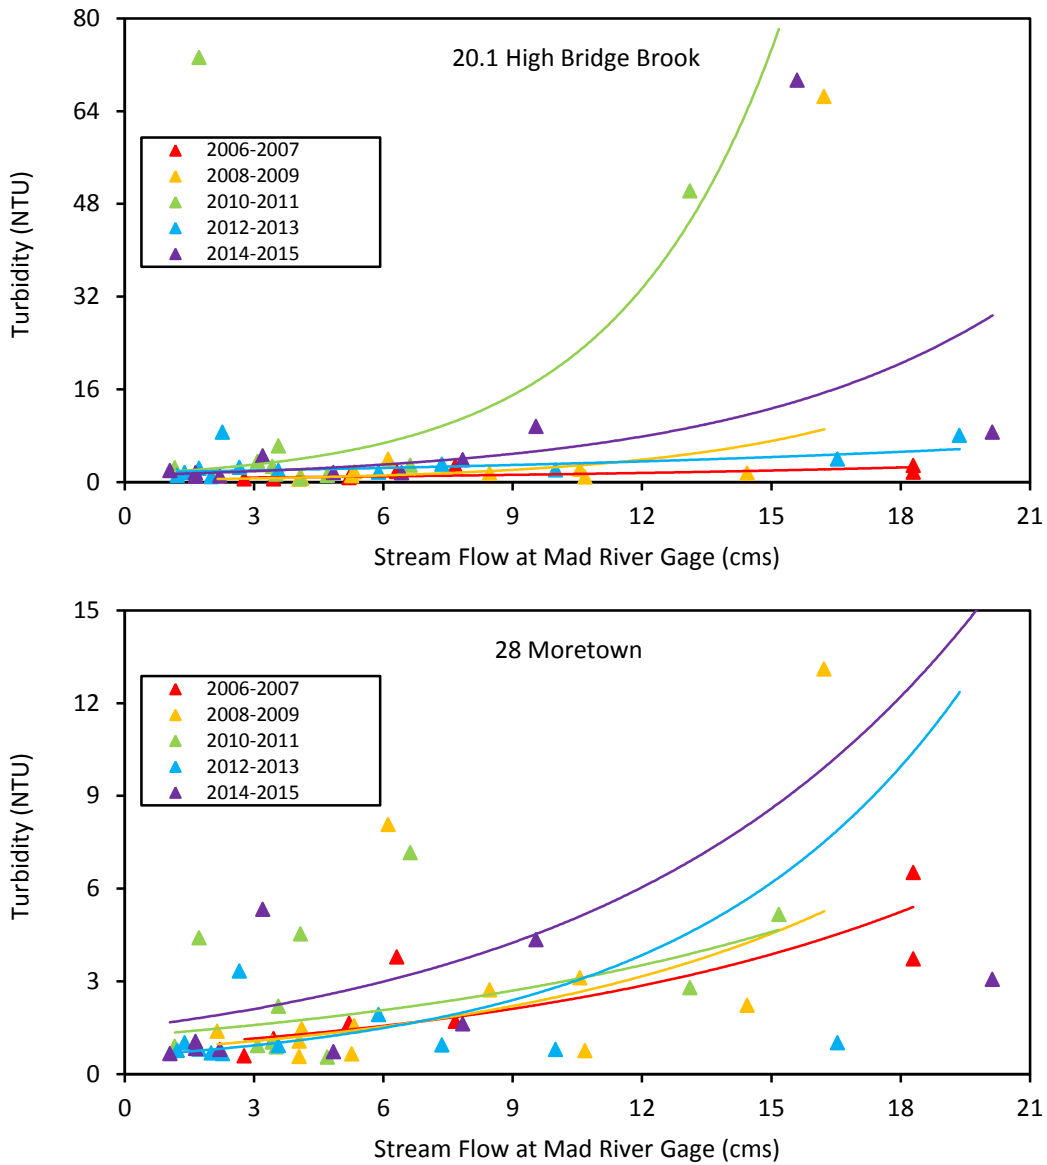
Figure 29. Turbidity levels in relation to stream flow at two sites [Site #20.1 (High Bridge Brook) and Site #28 (Moretown)] at two-year intervals during 2006-2015. Stream flows were measured at the USGS stream gage on the Mad River near Moretown, Vermont (USGS station 04288000). The regression lines indicate the exponential relationships between the two parameters. Note that two extreme high flows were not included in this analysis.

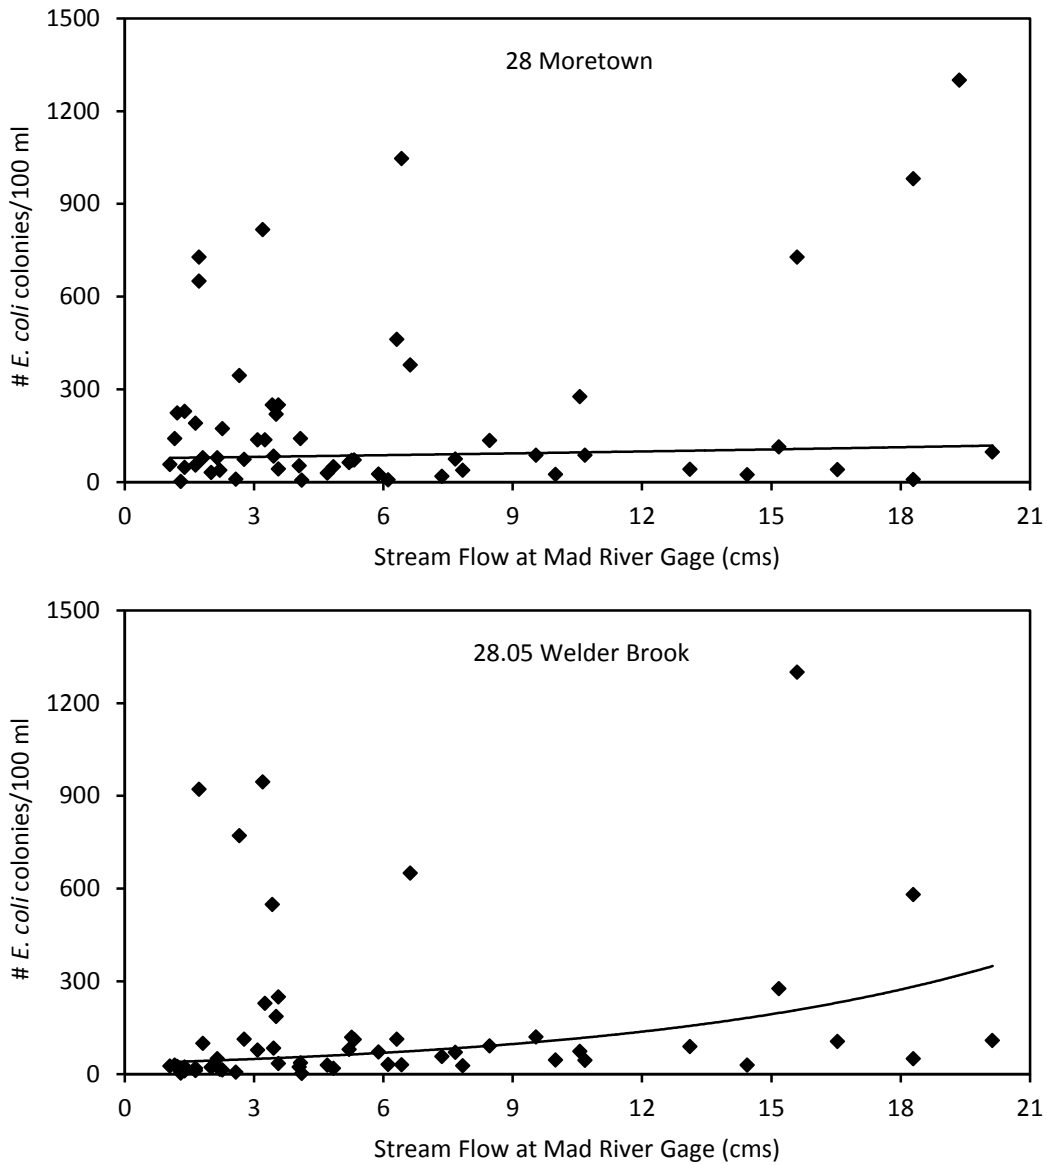
Figure 40. *E. coli* counts in relation to stream flow at two sites [Site #28 (Moretown) and Site #28.05 (Welder Brook)] along the main stem and a tributary of the Mad River during 2006-2015. Stream flow was measured at the USGS stream gage on the Mad River near Moretown, Vermont (USGS station 04288000). The regression lines indicate the exponential relationships between the two parameters. Note that two extreme high flows were not included in this analysis.

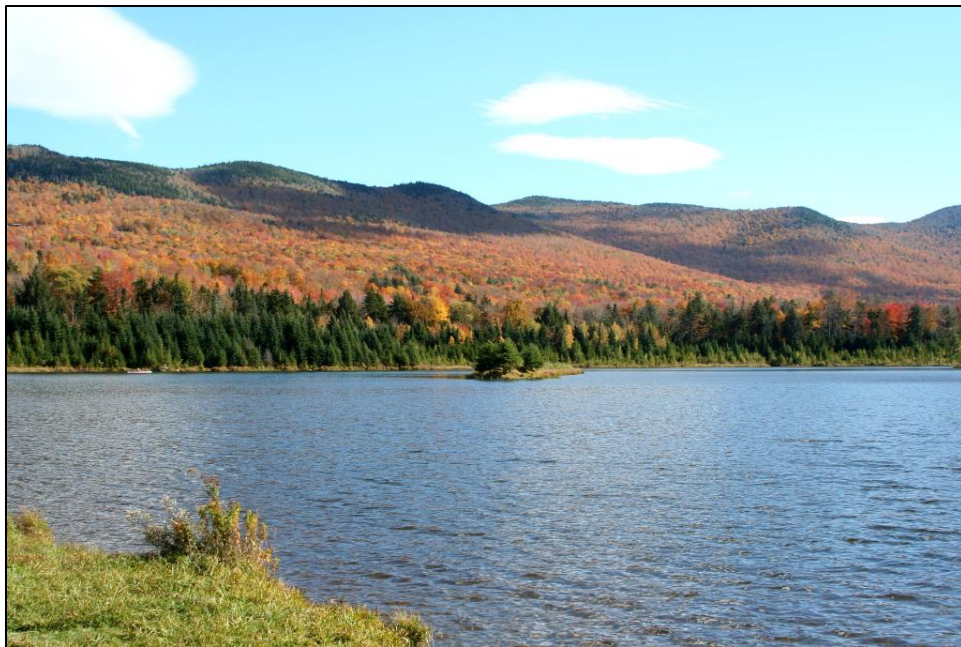
Figure 42. Blueberry Lake is the only significant lake in the Mad River watershed. This artificial lake is impounded by an earthen dam and is nestled at the base of the western slopes of the Northfield Mountains in Warren, Vermont as seen on 15 October 2015.
