River Corridor Protection and Management

FACT SHEET

Vermont Agency of Natural Resources

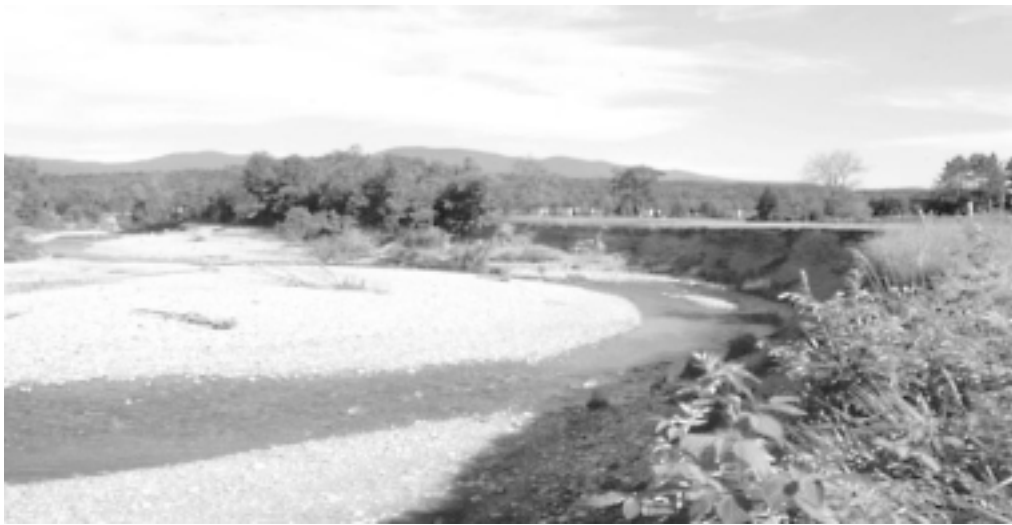
Previously channelized reach of the West Branch in Stowe, VT. Historic flood plain is on right at top of bank. Channel is now widening and forming a new flood plain at a lower elevation.

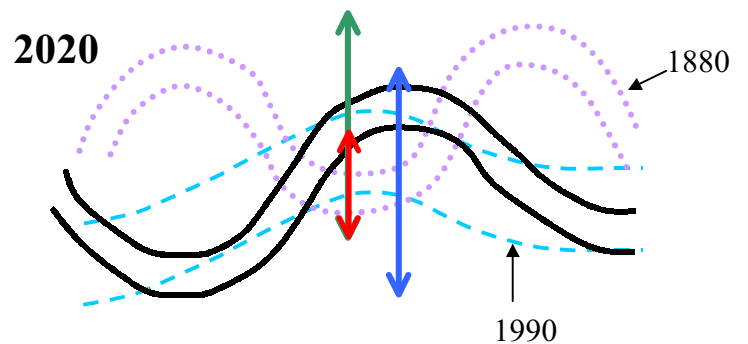
2020b Channel adjustment process is complete. Channel dimensions and relationship with flood plain are as they existed prior to channelization but at a lower elevation. Stable plan form (sinuosity) is restored but in a different location. Stable channel slope is achieved. Stream power is in balance with resistance of channel boundary materials and sediment transport needs.
